Historic Lighthouse Preservation Handbook

1997

PD-375

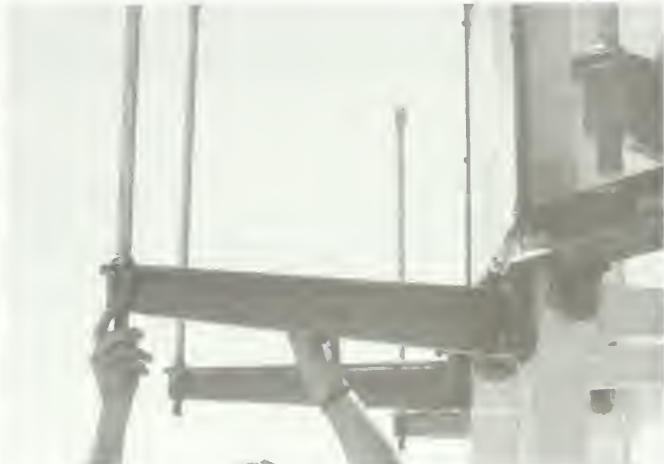
Figure 40 (above). The new gallery deck brackets after installation.

fabricated to match the original cast-iron brackets details. (This is another area where 304 S/S might have been better.) The stanchions were made of 1-inch 304 S/S round stock and 1-inch 316 S/S bolts. The bolts had a 1-inch diameter and 1/4-inch-deep recess machined in the head to ensure the bolts were properly aligned during welding. Custom 1-inch 316 S/S acorn nuts were then purchased to secure the stanchion to the brackets and the handrails. With the brackets and stanchions in place, the 3/8-inch flat bar handrails were then drilled, scribed, and fitted (see Figure 40).

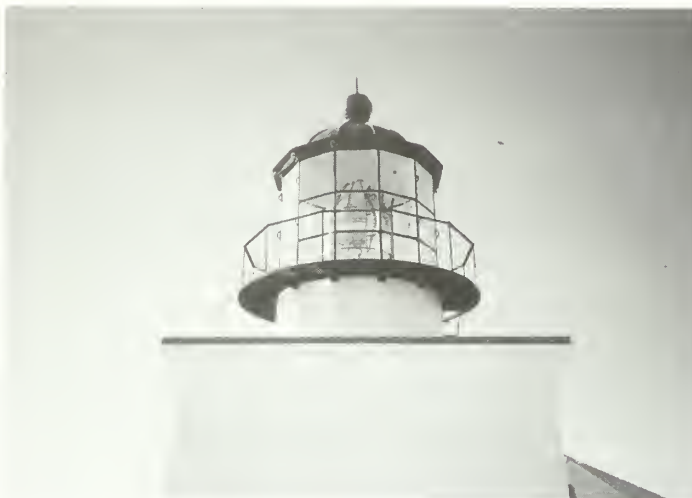
Figure 42. View of the Point Bonita Lighthouse after the gallery deck replacement.

on lighthouses understands dissimilar metals or even how to ensure that materials are properly reinstalled (see Figure 42).

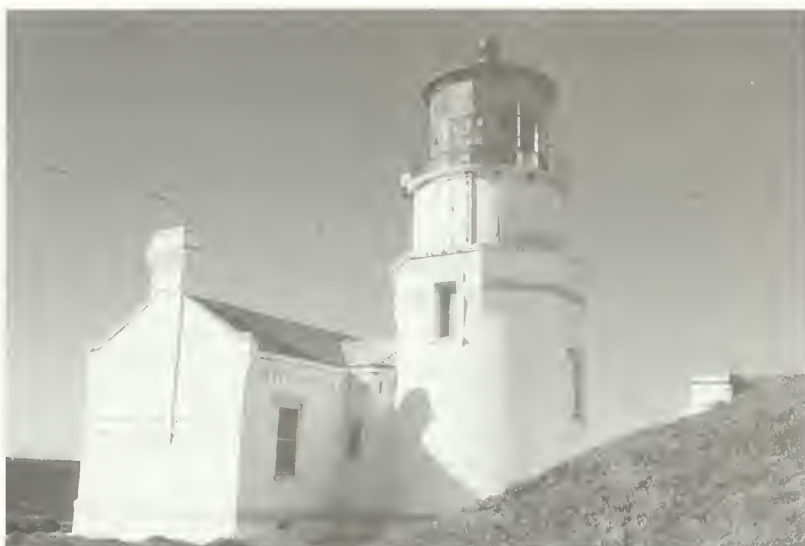
Figure 44. *Before the rehabilitation.* Note the doors at the watch room. A new louvered panel will be installed for added ventilation.

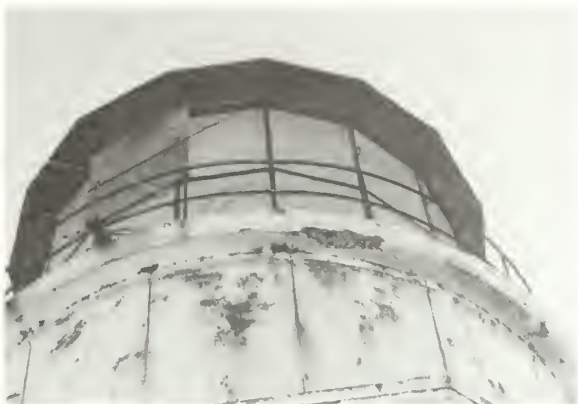
Figure 46. *Lighthouse lantern before rehabilitation.* Note the missing ladder rails and the severe rust on the lantern cornice and lower watch room panels. The badly spalled concrete gallery deck was installed in 1947 and is not original.

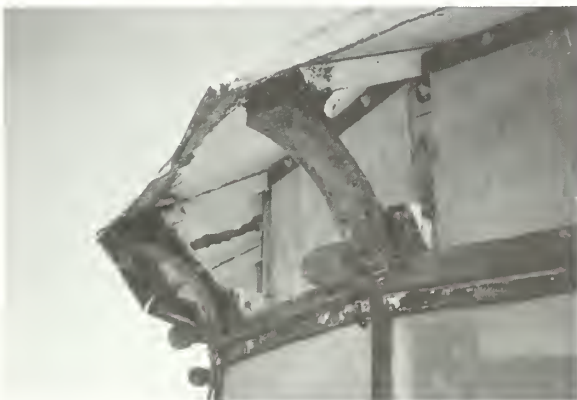
Figure 48. *Reconstructing the cornice.* The cornice plates were removed to expose the corroded cast-iron brackets and top channels. New brackets were cast in bronze, and the top sill channels were fabricated in stainless steel. Note the plywood 'curtain' erected for weather protection and shoring the lantern roof during reconstruction.

heavy rain washed out portions of the road, which cut off access for over a week. A special plywood 'curtain' was erected in the lantern room with clamps to protect the classical lens from the weather and shore up the lantern structure during reconstruction.

Although surface rusting was the main problem at the lantern, some of the deterioration was caused by galvanic reaction between dissimilar metals. Dissimilar metal problems were eliminated by replacing the original deteriorated cast-iron cornice plates and brackets with copper and bronze. The original copper roof dome was then stripped of its paint and allowed to naturally patina. Besides low maintenance, the other advantages of copper are its flexibility to withstand strong winds, building movement, and wide temperature changes. In other areas, neoprene gaskets, felt or teflon tape, thick epoxy primers, and bituminous paints were used between dissimilar metals to prevent future corrosion.

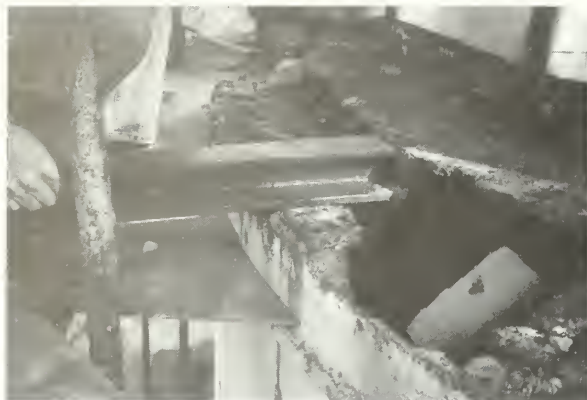
Figure 49. *Reconstructing the gallery deck.* After removing the existing concrete, remnants of the original cast-iron deck were found.

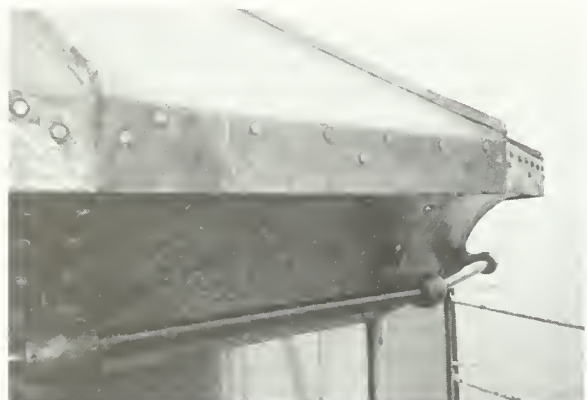
Figure 50. *Lantern cornice after rehabilitation.* Replacing the original steel cornice plates with copper eliminated the dissimilar metals problem.

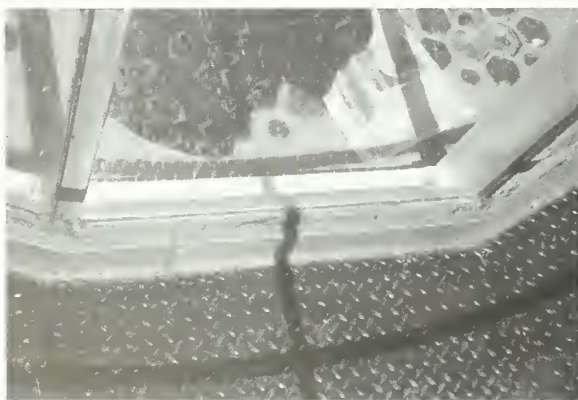
Figure 51. *Lantern galley deck after rehabilitation.* The new gallery deck was fabricated with stainless steel diamond plate and carefully flashed with copper at the lantern room. The interior lower sill channels were rebuilt to catch condensation from the glass.

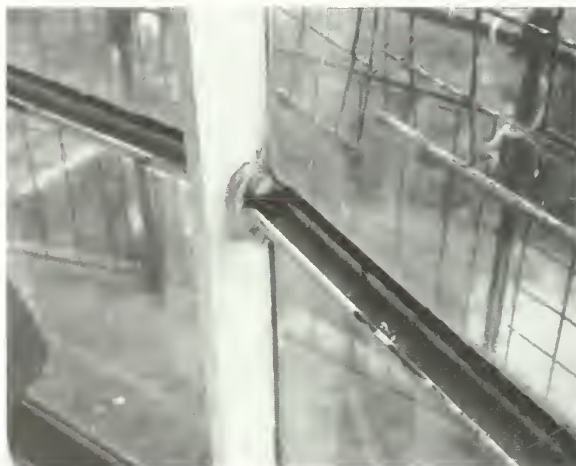
Figure 3 (above). Horizontal mullions run in between the stiles and serve to keep the stiles straight and frame the individual pieces of glass. Before restoration, the mullions and sills had been bolted in place over 140 years.

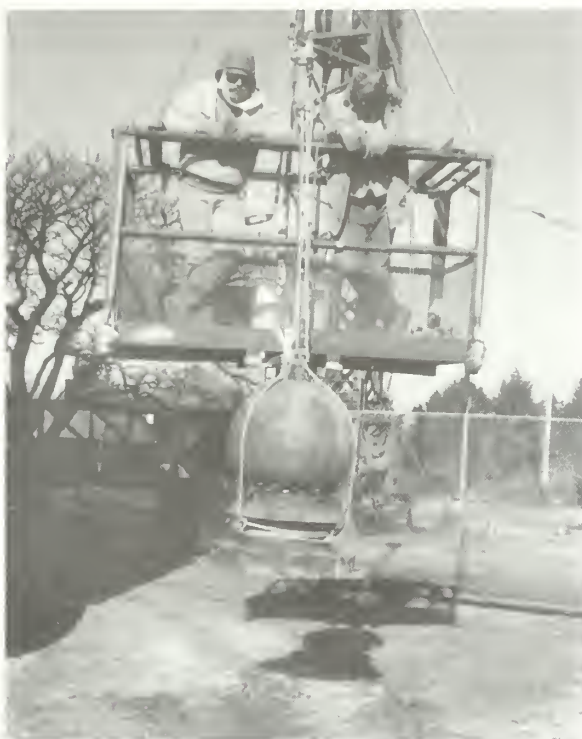
Figure 4. The first step in removing the roof was to take off the vent ball. The vent ball not only serves as a lightning rod but also provides ventilation to the glass in the lantern room, limiting condensation.

system of cantilevered beams that concentrated the load on the brick column of the tower. A lifting jig was designed and installed underneath the roof, and the roof was disconnected from the window wall system.

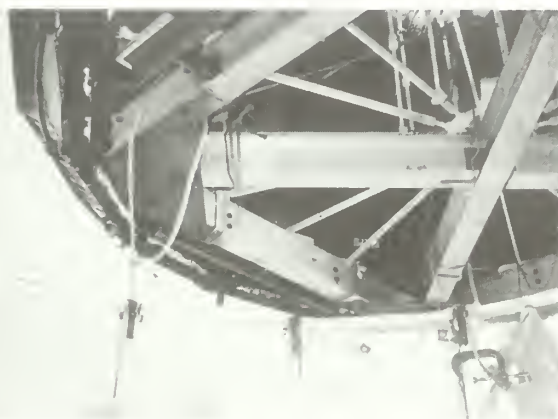
Figure 5. As the roof is being removed from the lighthouse, the tie rod system, supported by ICC's aluminum roofing frame, is visible. This frame was designed to fully support the roof and alleviate any stress or strain on the roof during the lift. Protruding down from the roof are the ends of the rafters which connect to the top of the stiles.

In Buffalo, extreme care was required to restore the roof without compromising dimensional integrity of the 16 tie rods and 16 roof rafters. The roof would be reinstalled in the same position, mating in 16 individual points, bolting together in 48 individual machined holes. The roof measured over 13 feet in diameter; restoration included replacement of the original cornice brackets that held the roof to the window wall and kept the shape of the copper. A 1/16-inch difference at each location would add up to a one inch deviation, preventing the roof from fitting.

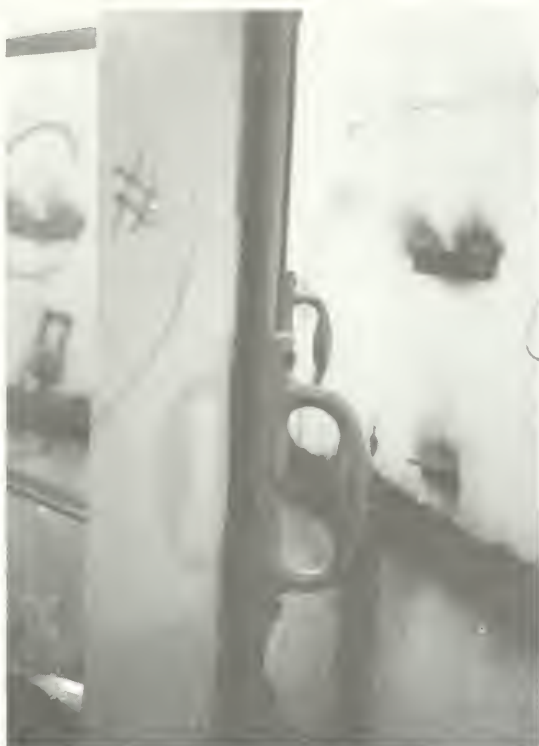
Figure 8. New hand holds were replicated to replace missing pieces. These exactly match the originals.

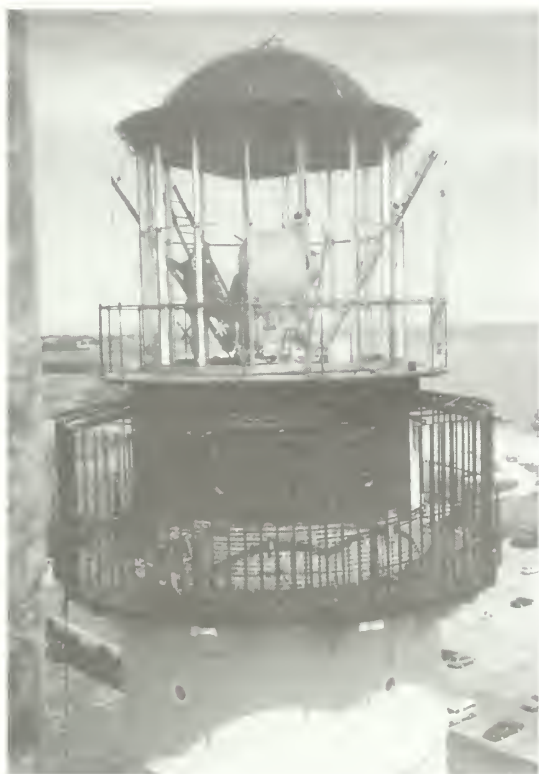
Figure 9. The refurbished roof is replaced on the lantern room. The fit is almost exact.

Meticulous preparations were made on the ground and in the air for the lift. The refurbished roof was centered as close as possible to the center line of the lighthouse and turned to allow for the proper fit in its original position. ICC's craftsmen were perched on ladders waiting for the roof to be hoisted. When all was ready, the signal was given and the lift began. The roof was centered above the window wall and began its descent. The result was anticlimactic. The roof came down exactly into position as if sucked in by a giant magnet. The major portion of the restoration was complete.

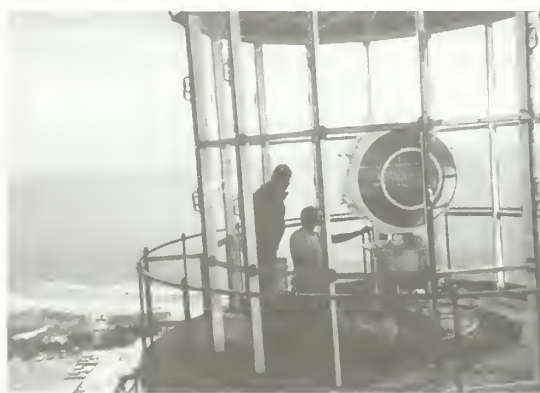
Figure 10. All glass is now in place and final preparations are made for the reopening.

New safety glass was installed on the window wall system, and the 'soup can' was no longer needed. A relatively calm wind would be required to remove the enclosure and set down the newly refurbished roof. On the June 4, 1994, conditions appeared favorable. The enclosure was lifted and, for the first time in five months, the efforts of the craftsmen were revealed. The newly lacquered bronze mullions, glazing bars, and sills gleamed in the bright early summer sun.

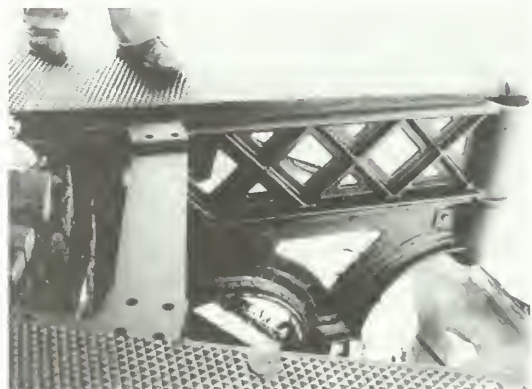
Figure 13. After the most severely deteriorated portion of the brackets were removed, new cast-iron pieces were made and installed; and new deck plates installed.

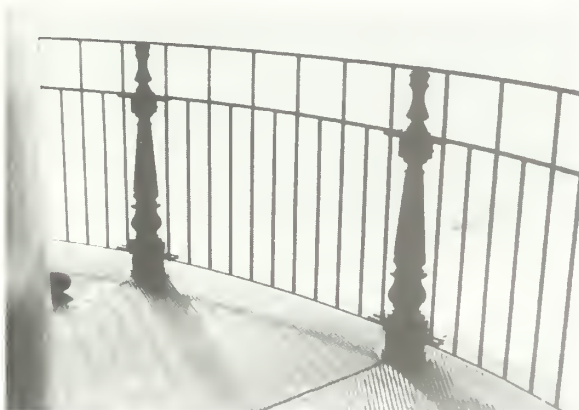
Figure 15. A replica handrail is installed.

When repairs were completed to the Bonner Bridge, exterior work could begin. A 7-foot-wide, circular work deck was placed below the large gallery deck. This afforded access to the complete hand rail system and deck plates. The hand rail components were carefully removed, as were the deck plates. The surviving pieces of deck plate were so deteriorated that accurate measurements could not be made. The deck was recalculated and a template made of the theoretical size and shape of the new deck plates. This was custom-fitted to each individual bracket, revealing that the lighthouse was slightly out of round. Measurements were taken for each individual section, which required custom casting, machining, and fitting of each individual section of plate. The brackets supporting the plate were reworked, and individual components recast. The belt course holding the brackets together below was removed, the masonry underneath repinned, and the cast belt course reinstalled. Deteriorated masonry was carefully cut out and repainted, as was the granite pedestal at the base.

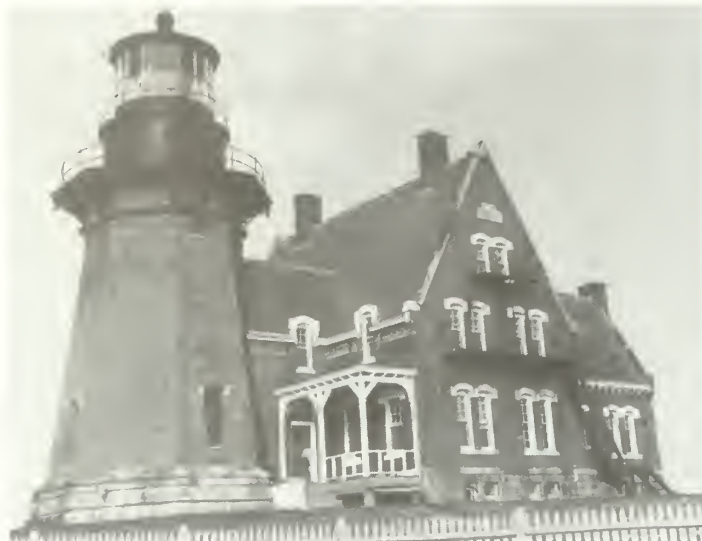
Figure 11. Block Island Southeast Light Station before the move.

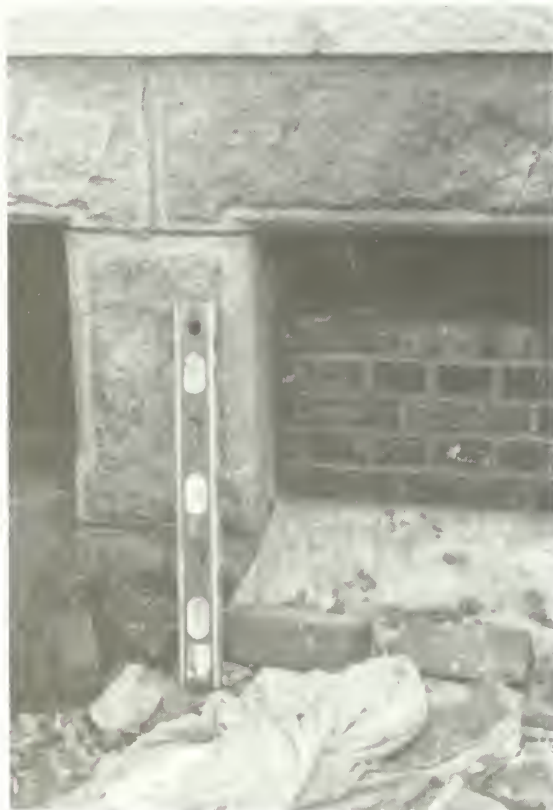
Figure 12. In preparation for the move, the cellar windows openings are temporarily bricked in to stabilize the masonry above the lift point.

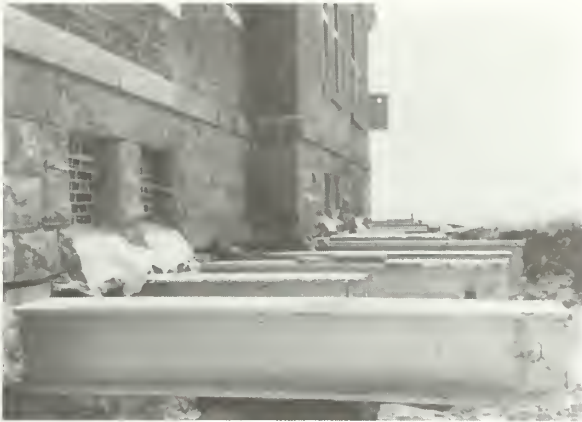
Figure 18. Large cross steel beams are inserted into the cut opening to form part of the grid that will carry the building.

An ingenious and complex system was devised to move the lighthouse over its 360-foot journey. Pete Friesen, a noted consultant in the house-moving field worked with ICC to design the move. In simplified terms, the entire weight of the lighthouse (estimated at a total of 4,000,000 pounds) was to be transferred from its masonry foundation to a grid of

crisscrossing steel beams and then pushed along tracks to its new home. The tracks were made of steel beams with case-hardened strike plates and laid on oak cribbing along a zig-zag path between the old lighthouse location and the new. In all, approximately 800,000 pounds of steel was used in the beam grid and track system.

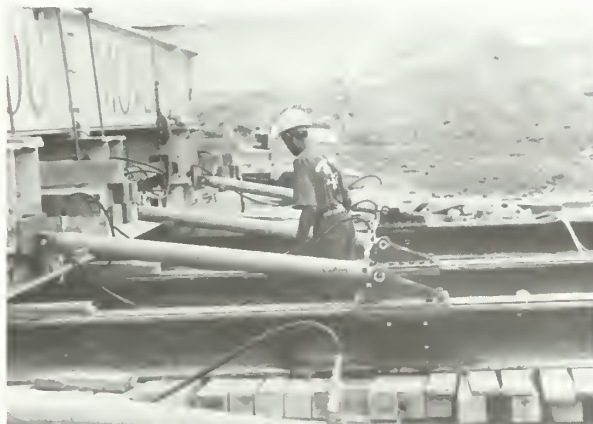
Figure 20. Four hydraulic rams set into the track steel pushed against the main steel to set the lighthouse in motion.

The move was accomplished by pushing the lighthouse along its newly installed track system in 5-foot increments with four hydraulic pushing rams (capable of pushing 30 tons each). After the lighthouse was pushed approximately 5 feet, all four pushing rams had to be retracted for the next 5-foot move. The lighthouse did not travel in a straight line from its original location to its new home. If this were done, loads on the network of beams under the lighthouse would have become too uneven. Instead, the move was accomplished in three separate stages (legs). Time was required between legs of the move for changes in the track system in preparation for the 90-degree change in direction the lighthouse was about to take.
